Network Demand Management Case Study— Willows Shopping Centre, Townsville

September 2011

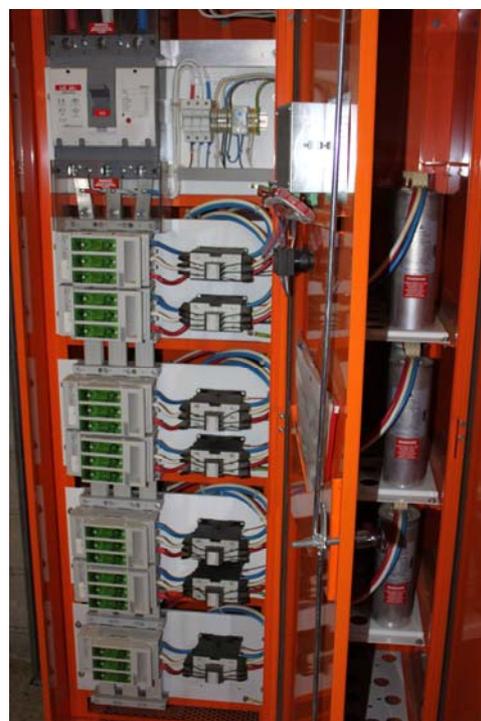
Power-factor correction equipment in the older part of the shopping centre.
