Part of Energy Queensland

Guideline for Inspection of a Private Property Pole by an Electrical Contractor

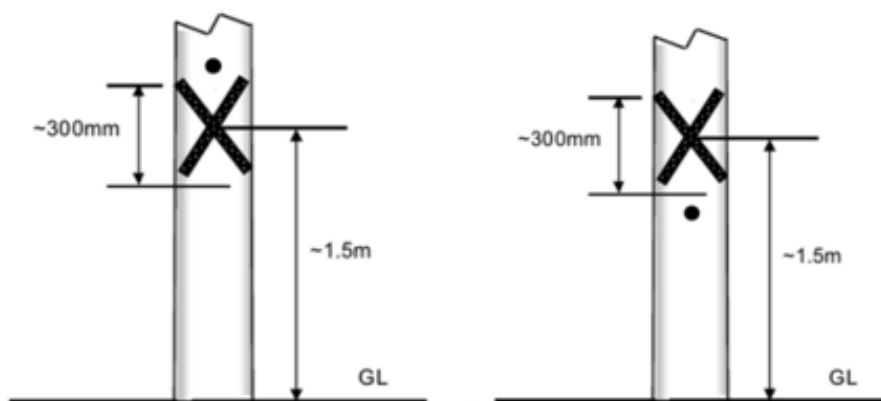
Figure 1 - Unserviceable Pole Markings

Where it is determined that the pole condition is Unserviceable, place a cross on the pole in accordance with Figure 1 to alert any person working on or near the pole of its condition. Apply the mark using yellow, fluorescent paint on the most visible side of the pole at a height of approximately 1.5m. The length of the mark shall be approximately 300mm.

Where a Pole Top Defect causes the pole to be classified as Unserviceable, then a small dot shall be painted above the cross.

Where a Pole Base Defect causes the pole to be classified as Unserviceable, a small dot shall be painted below the cross.

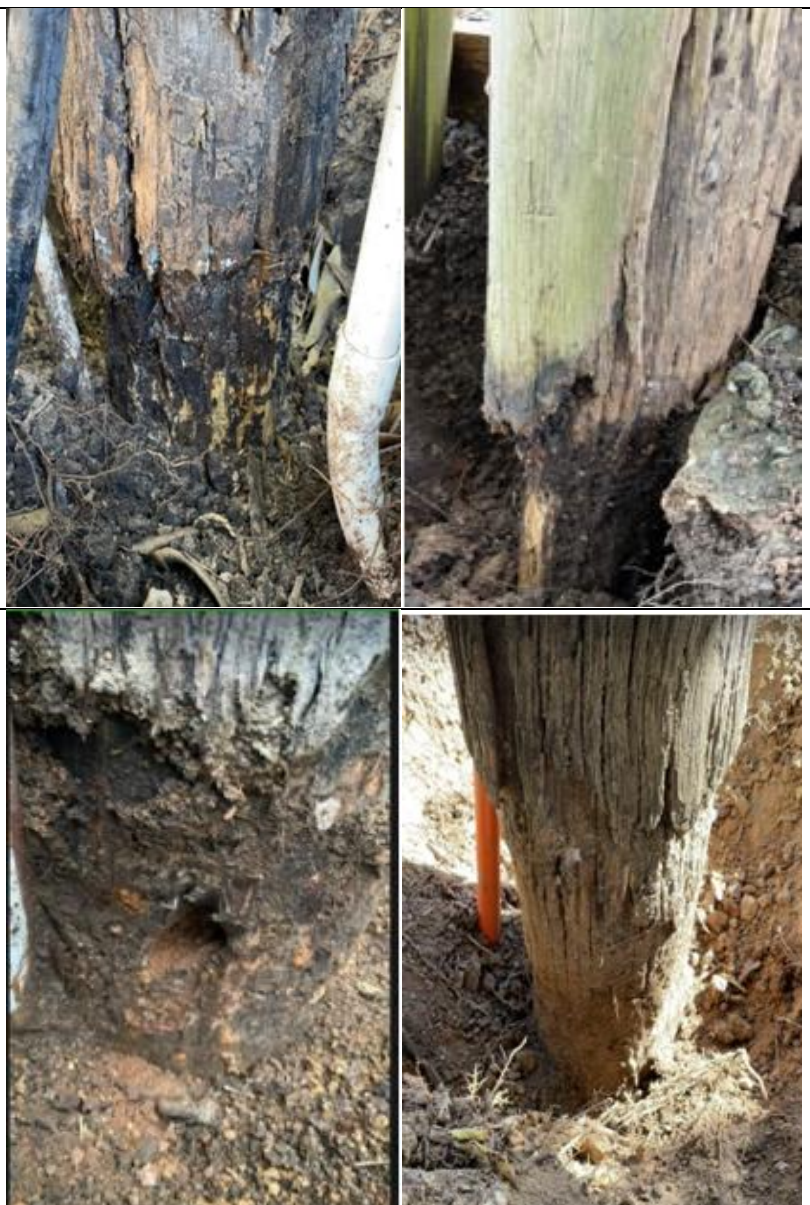
Deterioration of Wood Poles

The poles are deteriorated due to internal or external rot / decay

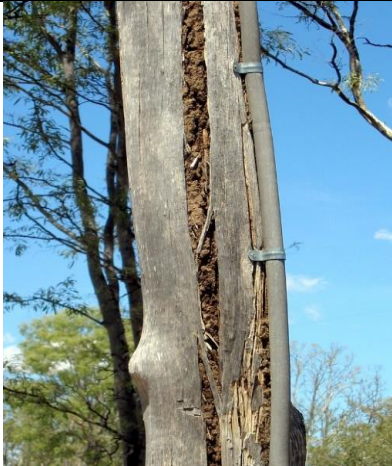
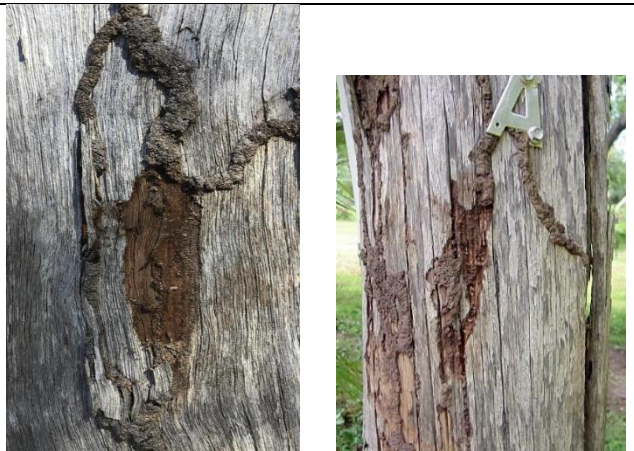
Deterioration of Wood Poles (continued)

<p>Deterioration on wood poles may be caused by:</p> <ul style="list-style-type: none">• Rot• Fungal fruiting body• Termites• Splitting or cracking

<p>This pole has active termites present. Termite treatment may be required by the customer.</p>

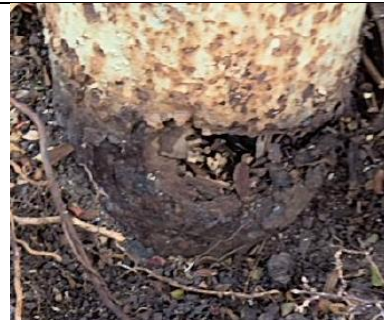
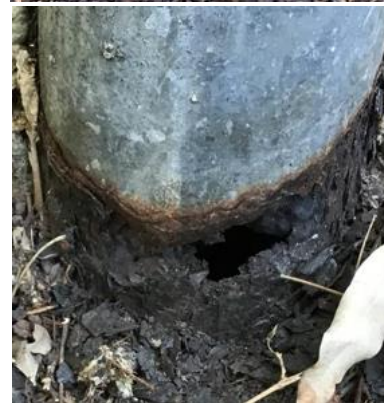
Deterioration of Metal Poles

The metal structure is deteriorated. Corrosion or other damage has resulted in a weak point, with evidence of one or more of the following:

- Flaking and deep pitting of the metal for greater than 75% of the circumference with a loss of cross-sectional area
- One or more holes in the metal greater than 20mm diameter
- Severe structural cracking
- Multiple weld cracks

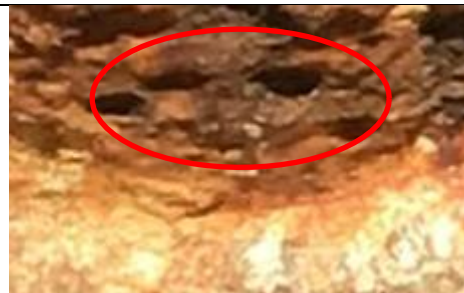
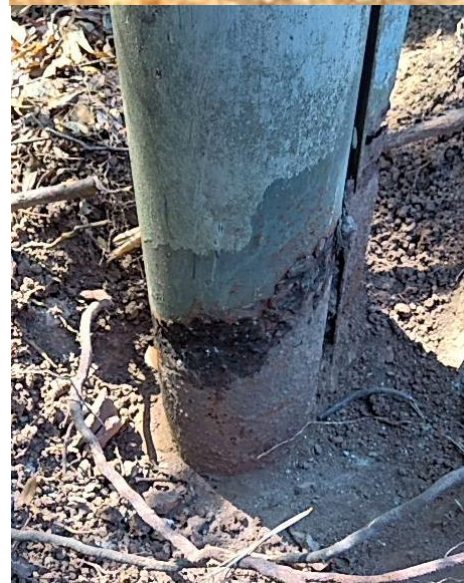
The metal structure is deteriorated with one or more of the following:

- Flaking and moderate pitting to greater than 50% of the circumference
- One or more holes less than 20mm in diameter
- Moderate structural cracking
- Up to two weld cracks

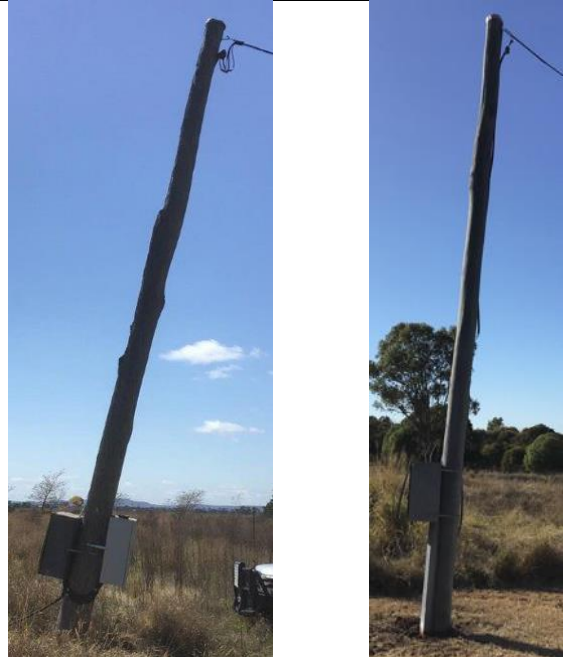
Pole Leaning

The pole has a foundation failure causing a moderate or excessive lean.

- loss of concrete over reinforcing
 - severe corrosion at the interface to the ground which may indicate deterioration below ground
2. Check if the pole is leaning or has not moved in the ground due to excessive load or due to weakening of the pole below ground. If leaning by $>20^\circ$, **urgent** replacement is required. If leaning between 10° and 20° , **non-urgent** replacement is required.

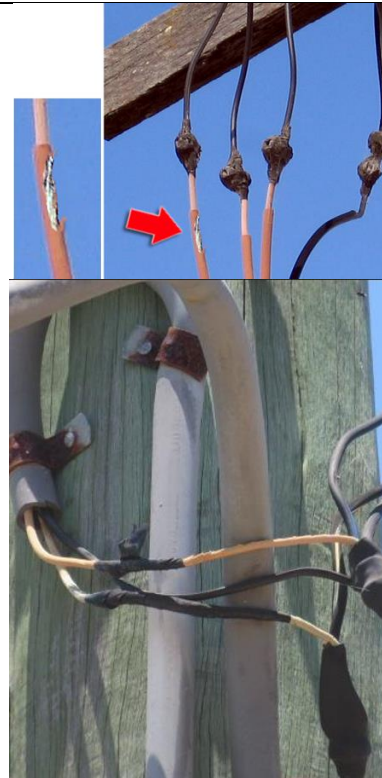
Conductor Damage

Consumer's mains with heavily deteriorated insulation with bare strands visible at wood pole top only.

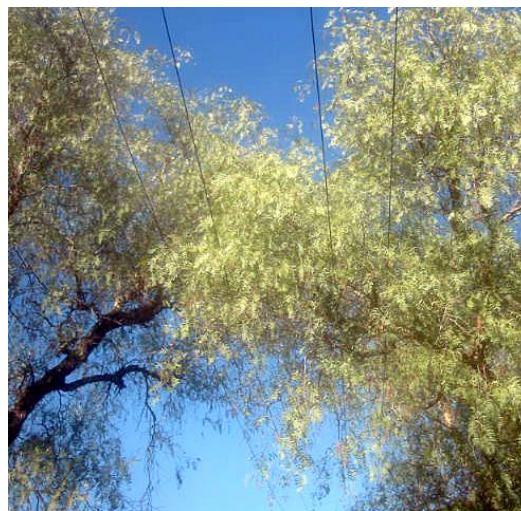
Vegetation Touching

Vegetation is contacting the private overhead electric line.
There is a risk of damage to the conductors or contact by a person climbing the tree in the short term.

This applies to bare conductors.

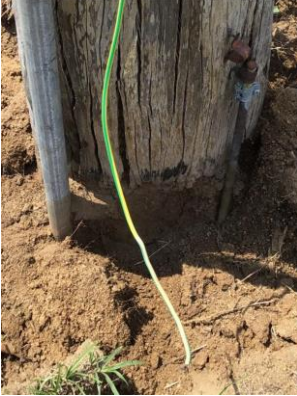
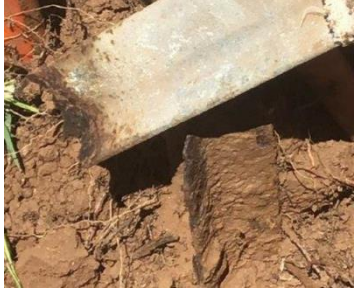
Underground Equipment

<p>The Customer's Earth is not connected to the earth stake</p> <p>Or</p> <p>The Customer's Earth Stake is broken</p>

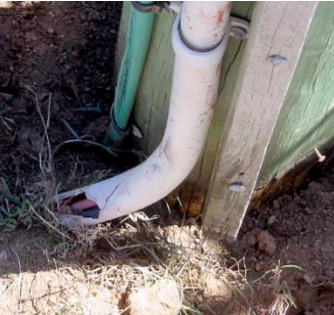
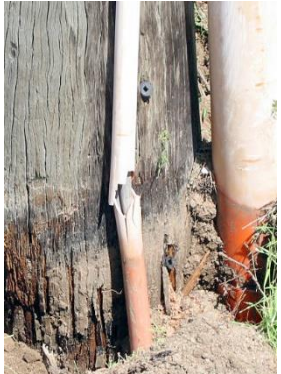
<p>The conduit and cables are damaged.</p> <p>If live cables or terminals can be contacted, treat as life threatening.</p>

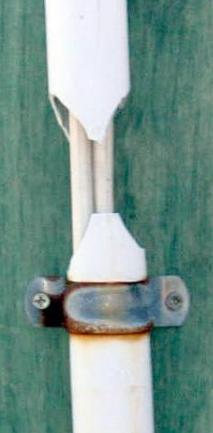
<p>The conduit is broken or saddles are missing and there is no damage to the cable insulation.</p>

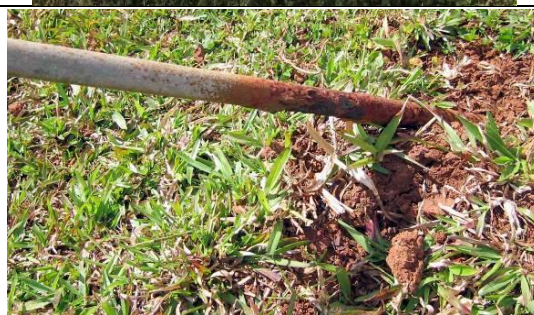
The stay rod, cable, or attachments are damaged or moderately deteriorated.

There is a risk of the stay failing.

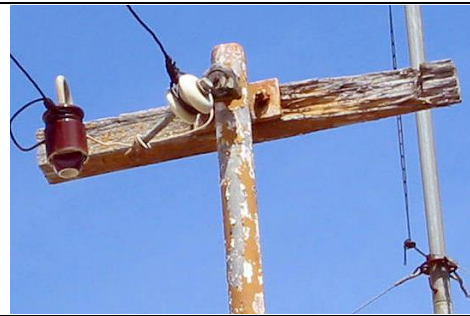
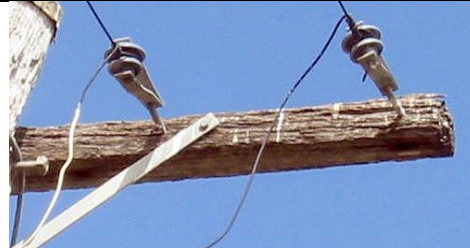
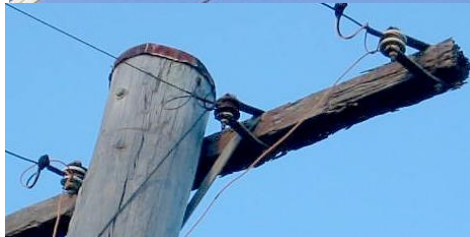
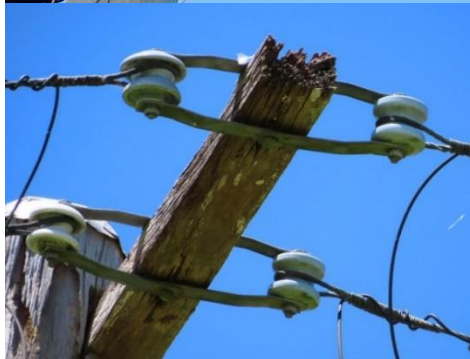
Cross Arms

Crossarm is deteriorated from rot, fungal fruiting body, termites, splitting or cracking.

The crossarm shows signs of cracking, splitting or deterioration along the length of the crossarm.

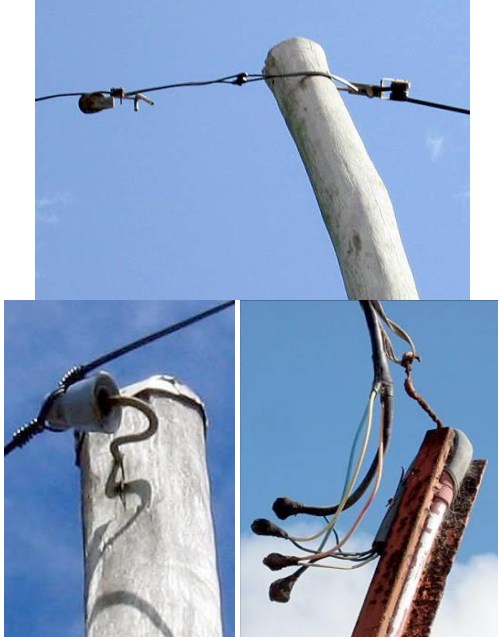
Conductor Pole Attachments

<p>The conductor fitting is broken or damaged.</p> <p>There is a risk of the conductor falling to ground.</p> <p>Life threatening if electrical connections are supporting tension.</p>

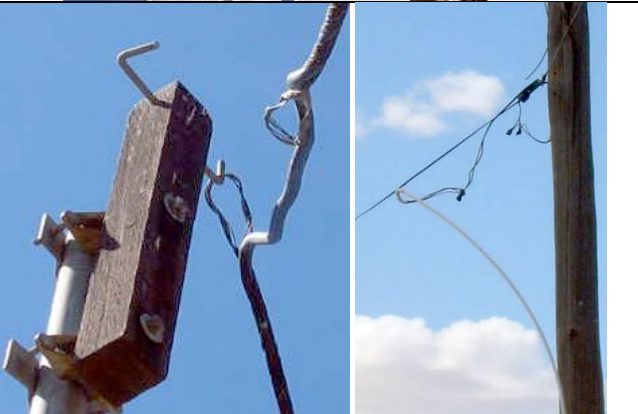
<p>The customer's attachment point has spun, the service is continuous and has one attachment remaining.</p> <p>Or</p> <p>Conduit has detached from the pole.</p> <p>There is a risk of the conductor falling to the ground.</p>

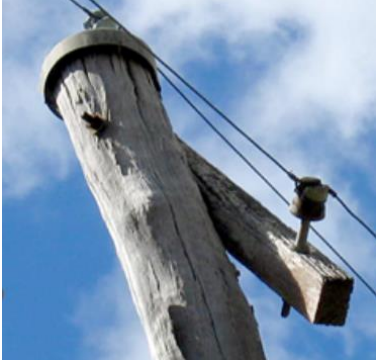
Conductor to conductor clearances

<p>The structure supporting the conductor is damaged and reducing the clearance between conductors.</p> <p>There is a risk of conductor clashing and fire.</p>

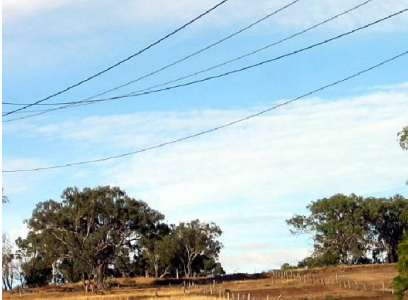
<p>The clearance between conductors is reduced.</p> <p>There is a risk of conductor clashing and fire.</p>

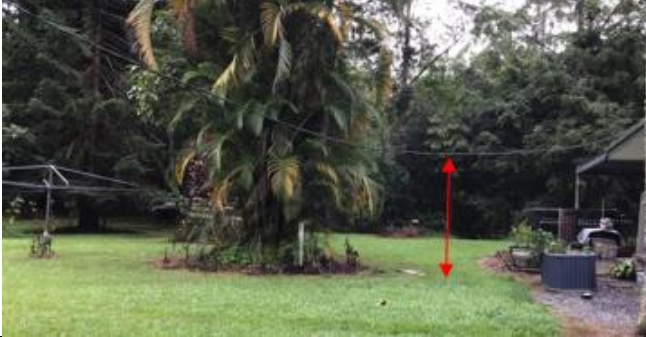
Conductor ground clearance

<p>The conductor clearance is less than 2.5 metres in an area not traversed by a vehicle.</p> <p>Bare conductors would be considered an immediate safety risk.</p>

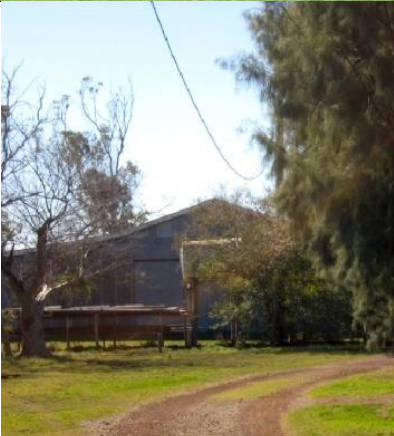
<p>Any visually identified conductor to ground clearance defects.</p> <p>Overhead conductor between 2.5 metres and 3 metres over a pathway/track.</p>

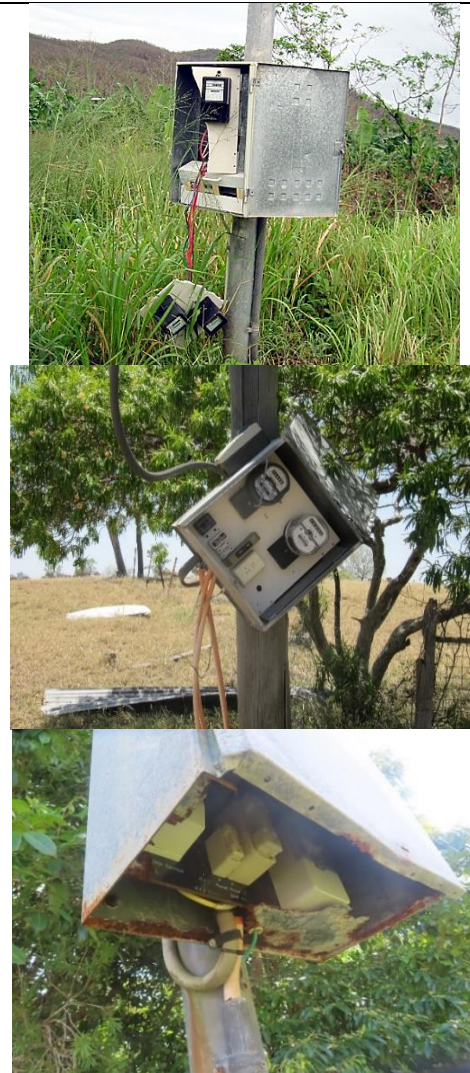
Meterbox

The meter box is severely damaged.

If live cables or terminals can be contacted, treat as life threatening.

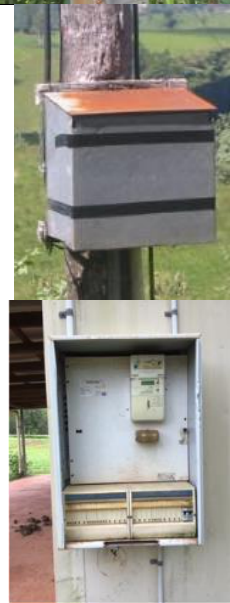
The meter box has minor deterioration.

NO Bare cables or live parts are exposed.

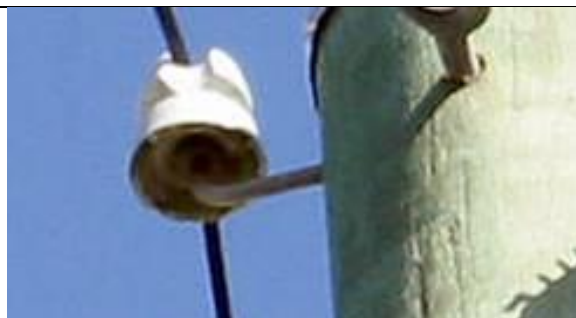
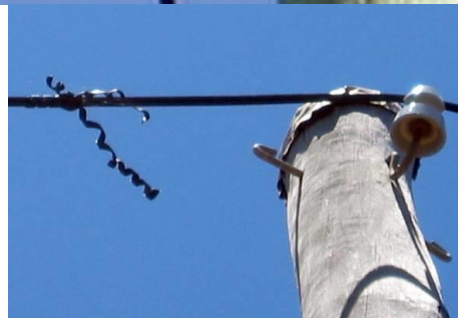
Conductor Ties

The conductor tie is missing or deteriorated and the conductor is unrestrained.

There is a risk of the conductor falling to ground.

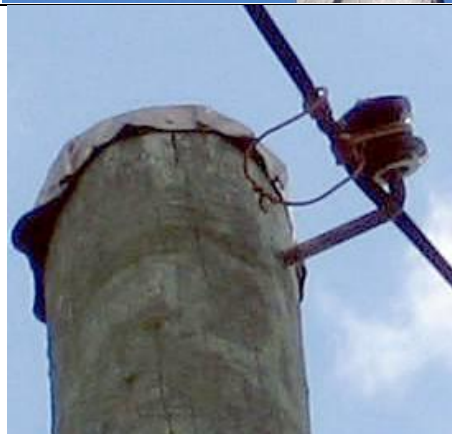
The conductor tie is broken or deteriorated and the conductor remains partially restrained.

There is a risk of the conductor falling to ground.

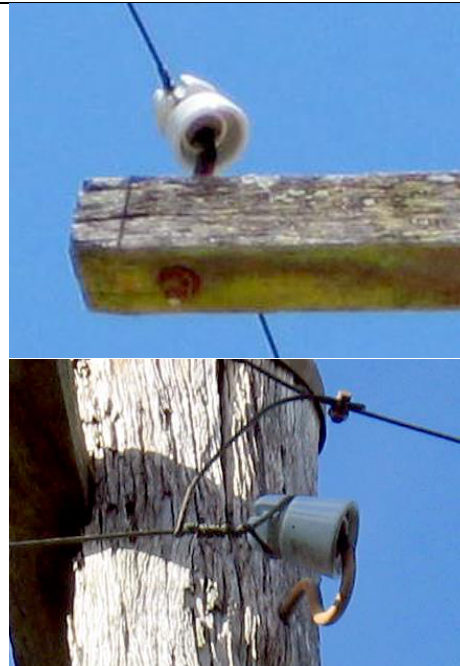
Insulators

Insulator support is broken or significantly deteriorated.

There is a risk of the conductor falling to ground.

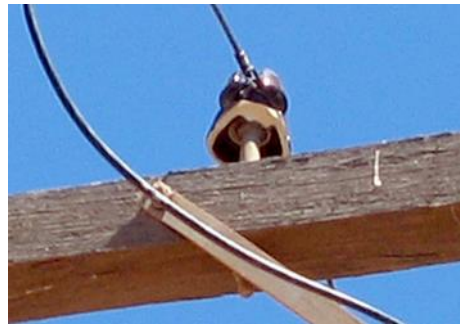
Insulator is damaged but remains structurally sound.

There is a risk of the conductor falling to ground.
