University of Southern Queensland Toowoomba

University improves network performance by 10%*

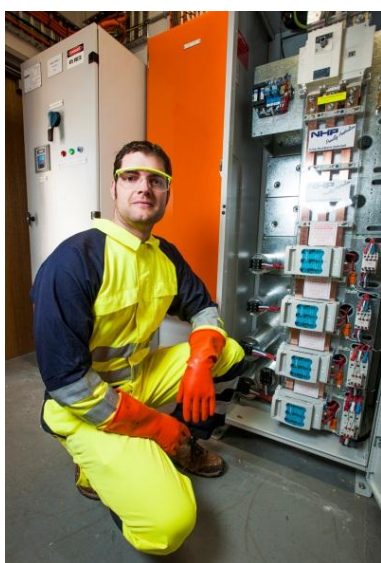
Above: James Glasby – Facilities Officer USQ Campus Services inspecting one of the eight capacitor banks installed

Capacitor banks were installed at nine out of 18 transformers across the campus between April and May 2013. An independent measurement and verification report conducted in May 2013 showed that the power factor correction systems maintained a power factor of 0.98.
